AES (Amman East Power Plant)

Gas Turbine No. 1

**Maintenance & Inspection of Rotor & Combustion
Chamber Lifting Beams**

Subject: Painting and NDT for Lifting Beams and their components.

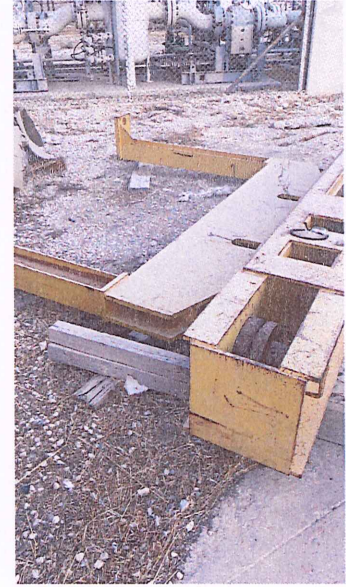
Combustion Chamber lifting beam before maintenance

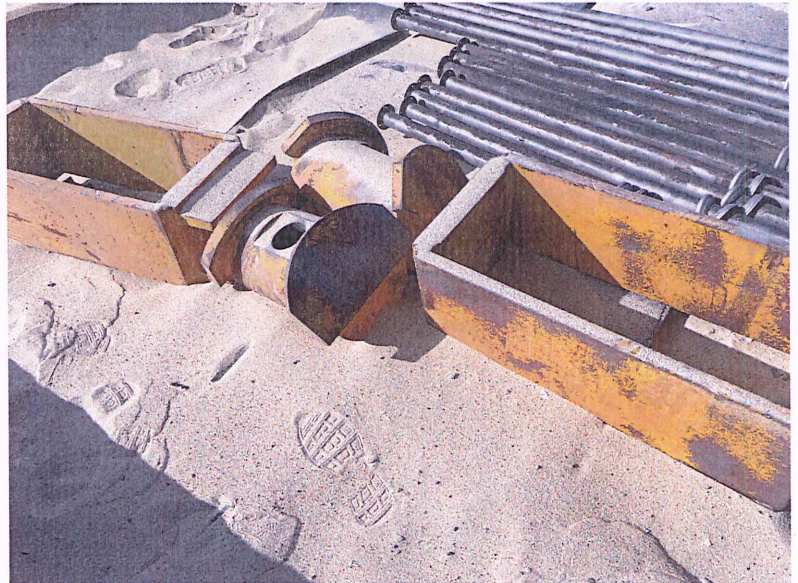
Rotor lifting beam Components
before maintenance

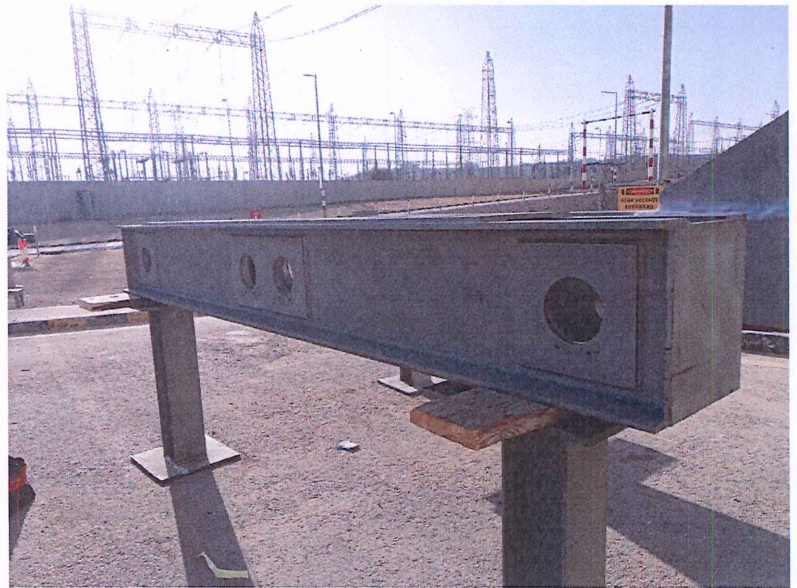
Combustion Chamber lifting beam after sand blasting

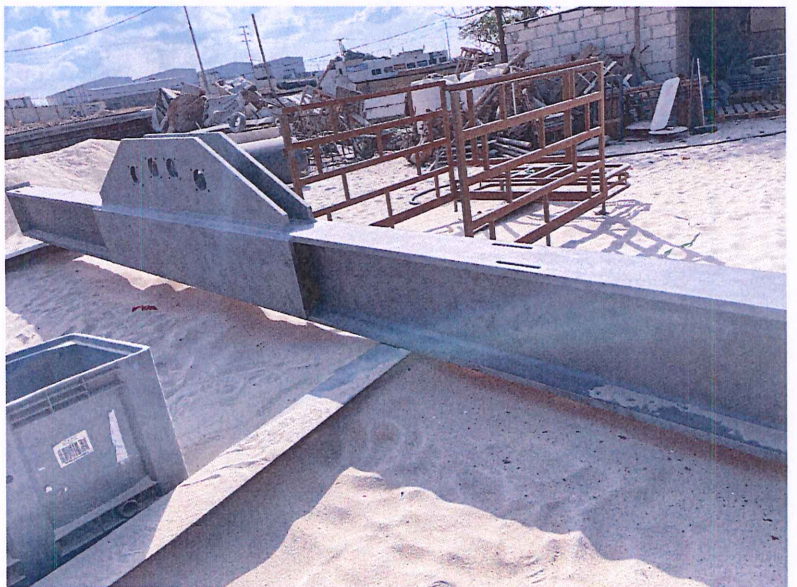
Rotor lifting beam after sand blasting

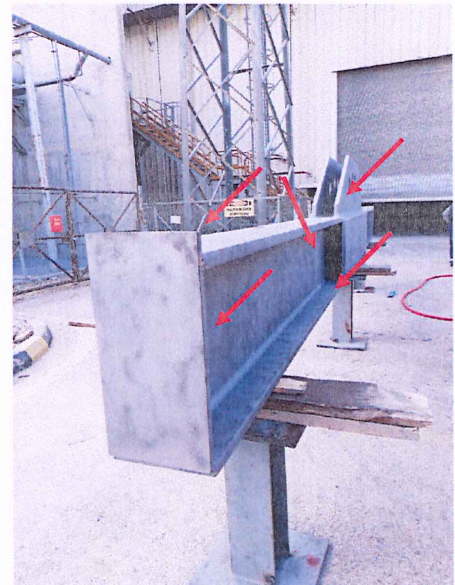
No indications in welding joints

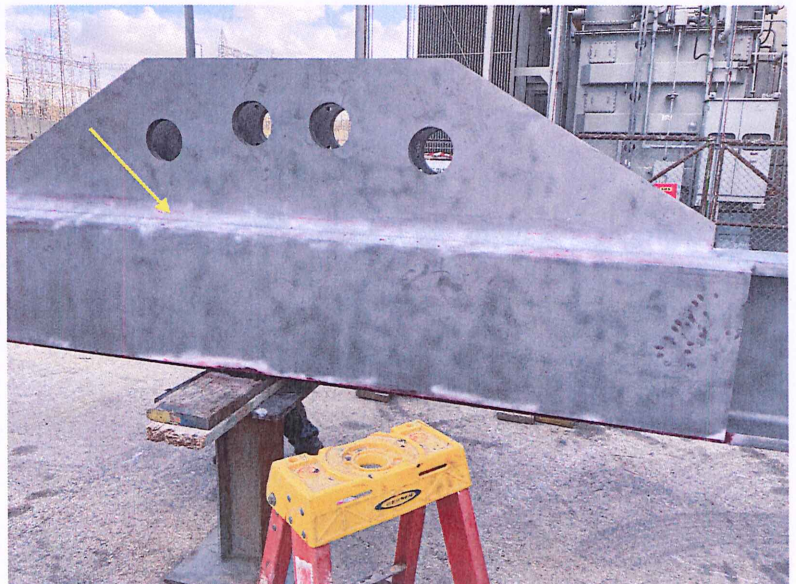
No indications

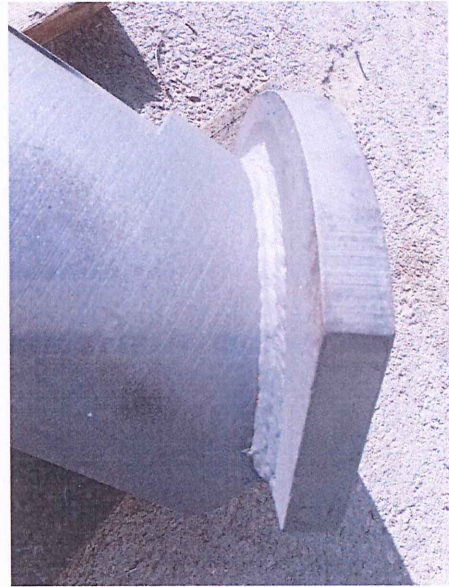
Component
VT
Good
No Indications

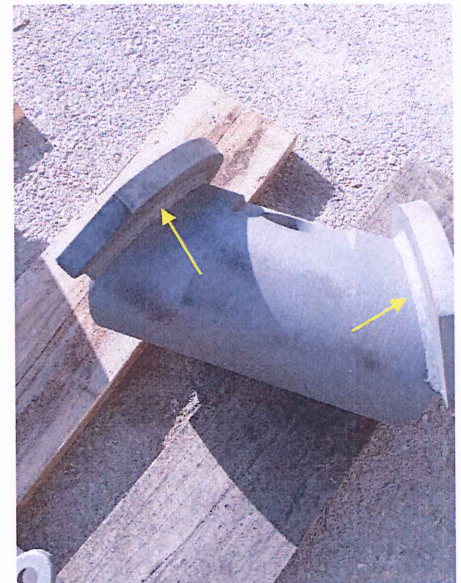
Component
No Indications

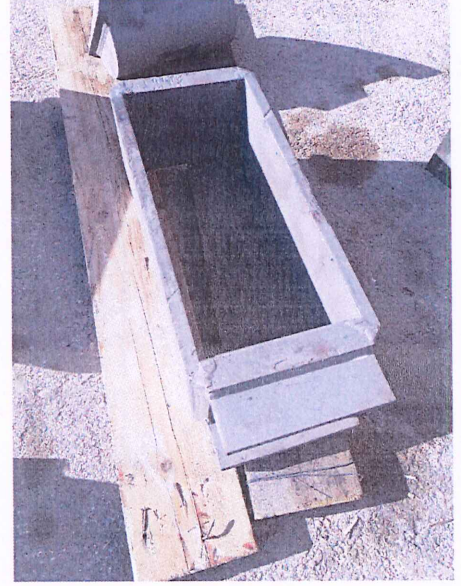
No indication in the components

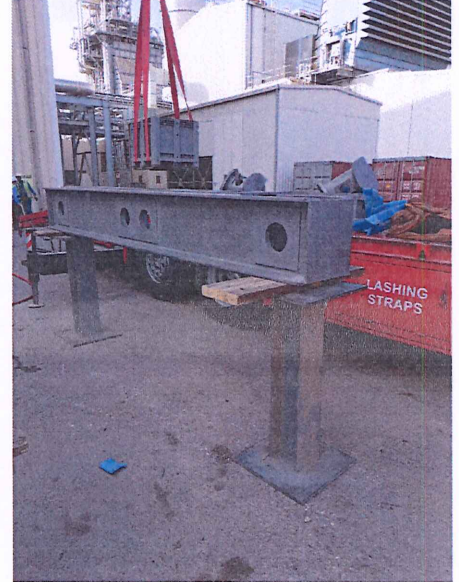
No indications in the welding

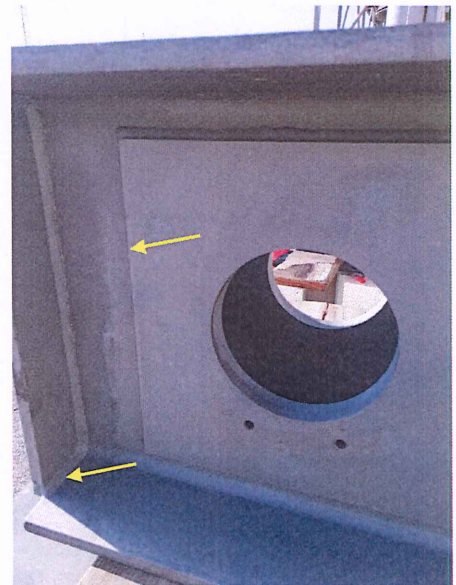
No indications in the welding

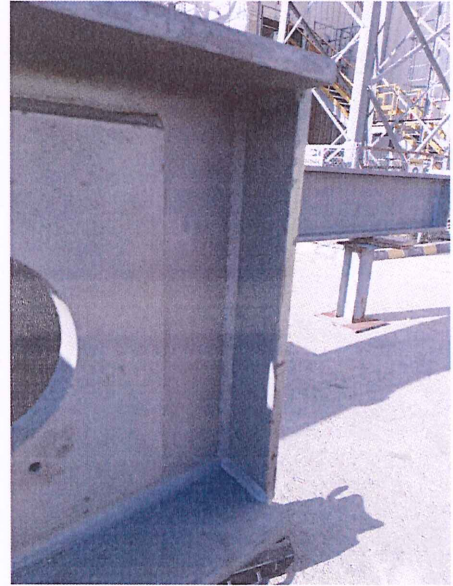
No indications

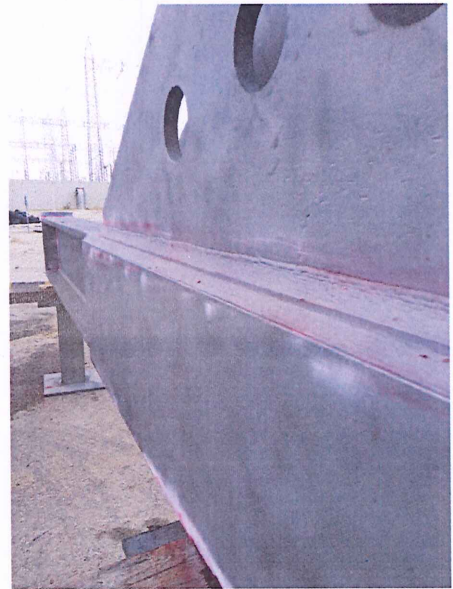
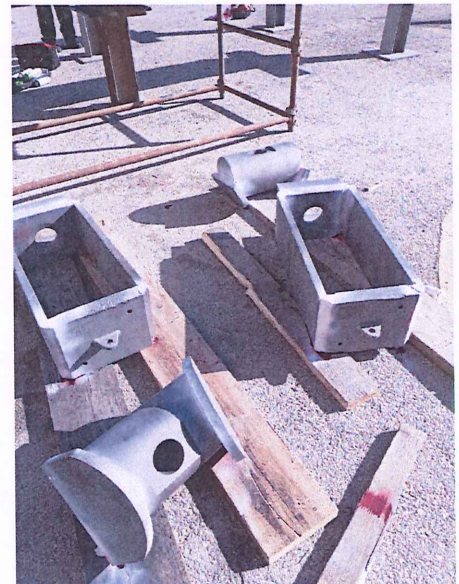
No Indications in the welding joints of the beam and components

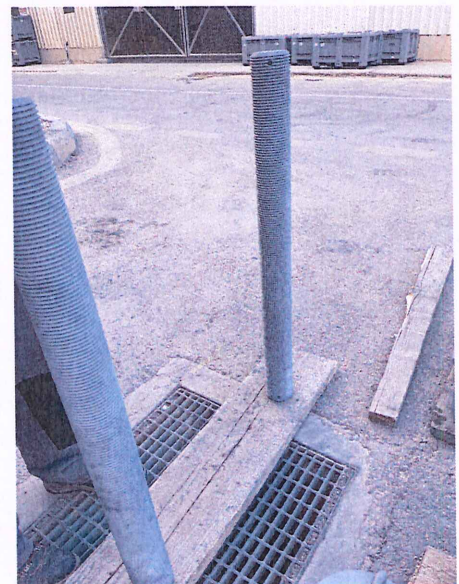
No indications

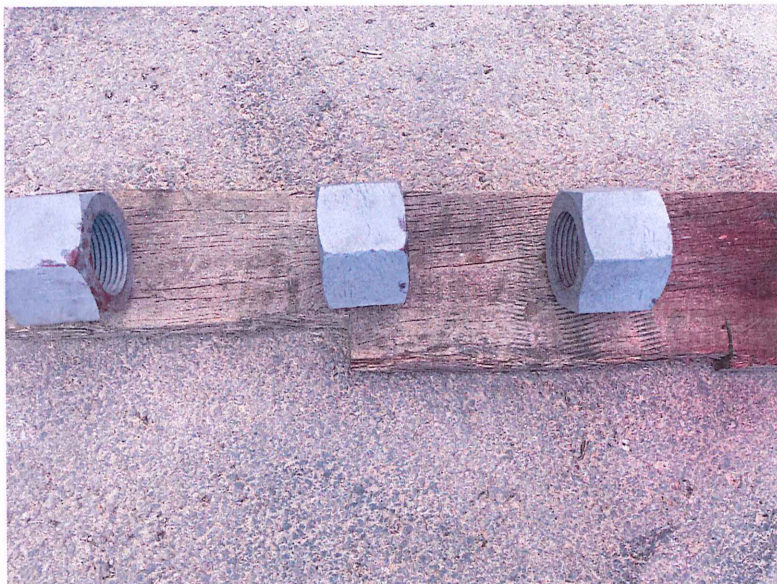
Nuts
No Indications

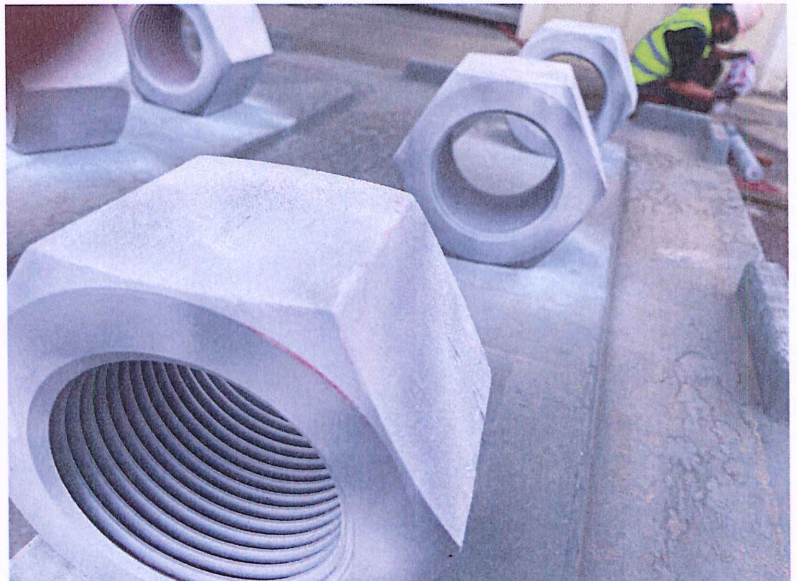
No Indications –
In Bolts and nuts

Accepted
